HOME INSPECTION REPORT

Premier Inspection Services, Inc.
118 North Conistor Lane Ste B #180
Liberty, MO 64068
Office Phone: 816.407.1617
www.kchomeinspector.com

Action Needed Summary

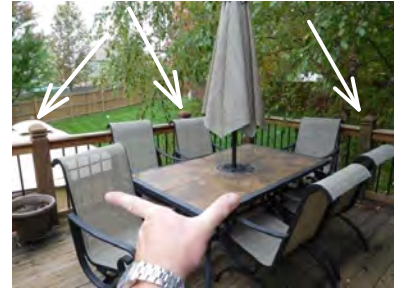
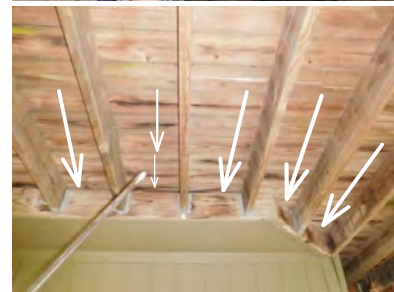
- 1. Deck Deck / Balcony / Porch Hand / Guard Railing:** Repair or replacement is recommended. Movement is noted at the hand / guard railing. Recommend properly securing the railing for added safety.
- 2. Deck Deck / Balcony / Porch Flashing at point of attachment:** Repair or replacement is recommended. Flashing is missing at the point of attachment to the structure. When installing a deck it is always recommended that flashing be installed behind the siding material that extends over the ledger board / band joist to prevent moisture from entering the structure at the points of attachment.

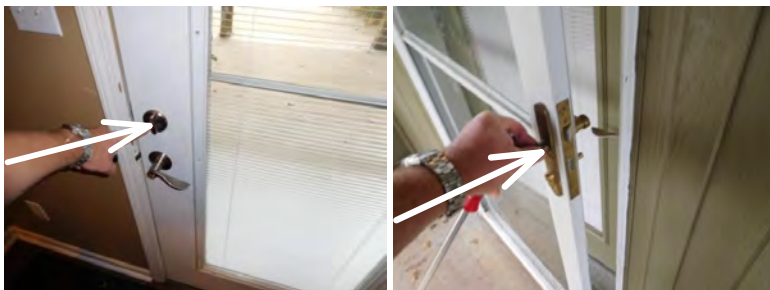
The storm door lockset(s) not properly latching / functioning; Recommend properly repair or replace.

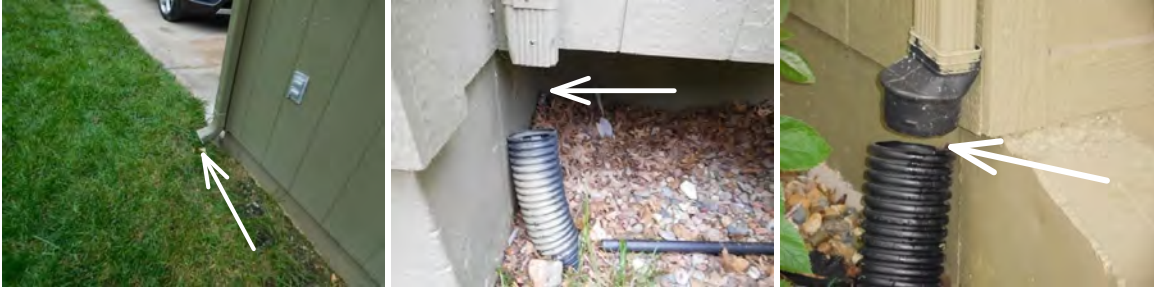
5. **Leader/Extension:** Repair or replacement is recommended. The downspout extensions are not properly installed, missing, disconnected or tilting towards the structure. This is allowing water to accumulate around the foundation which is known to cause foundation problems when left unattended also moist areas around the home are attractive to termites. Suggest extending leaders at least 6 feet beyond the foundation perimeter at a minimum to protect and prevent water damage to the foundation at all downspout locations.

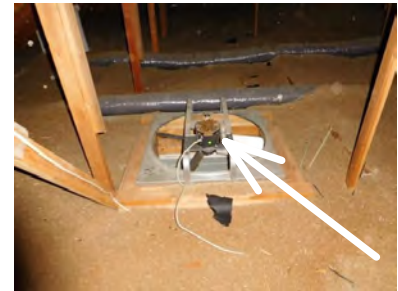
6. **ALL Attic Locations Attic Ventilation:** Repair or replacement is recommended. There is evidence of moisture / condensation building up in the attic area due to the moisture stains on the insulation. The moisture is building up and collecting on the roof sheathing and then dripping on to the insulation causing these stains. This condition is usually caused by improper ventilation of the attic and or heat escaping the living areas into the attic causing hot air to condensate. A qualified contractor is recommended to further evaluate and estimate repairs. Typically the improvements needed are 2 fold. 1.) Is to seal air penetration areas that lead from the living space to the attic and 2.) Improvements be made to the attic ventilation such as additional roof and or soffit vents. Current industry standards recommend, as a minimum, one square foot of free vent area for each 150 square feet of attic floor if no vapor barrier is installed. With a vapor barrier installed, one square foot of free vent area per 300 square feet of attic space is needed.

7. **ALL Attic Locations Attic House Fan:** Repair or replacement is recommended. The fan does not pull much air. Inadequate ventilation of the attic is noted along with the fan belt needs adjustment to properly vent the home. A qualified contractor is recommended to further evaluate and estimate repairs.

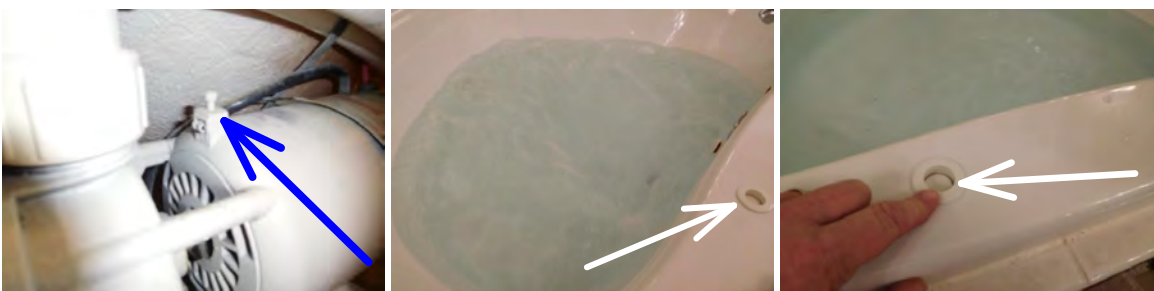
8. **Master Bedroom Bathroom Spa Tub/Surround:** Repair or replacement is recommended. The spa pump motor bond wire is missing / not attached to the motor housing ground / bond connection. Recommend properly bonding the spa pump motor. Typically the bond /ground wire is connected from the motor housing set screw and metal faucet / plumbing to the electrical panel. The control knob or push button is in need of repair or replacement due to it is stuck in the down position; Recommend the proper repairs be made.

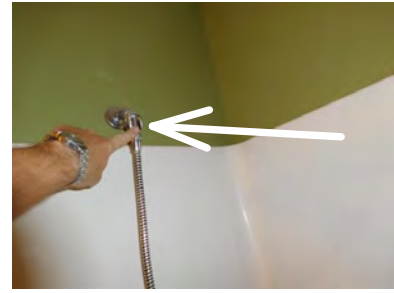
- 9. Bedroom Level Hall Bath Bathroom Tub/Surround:** Repair or replacement is recommended. The shower head bracket is broken and the shower head has to lay on the bottom of the tub. Recommend proper replacement.

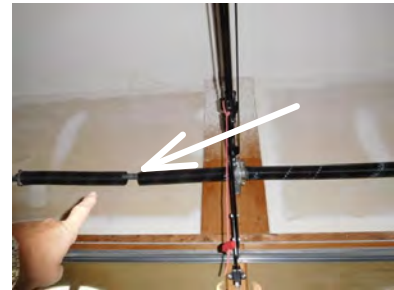
- 12. The garage is located at the front of the structure. Garage Door Opener:** Repair or replacement is recommended. The garage door opener was inoperative at the time of inspection. The garage door spring(s) is broken. Recommend proper replacement. A qualified contractor is recommended to evaluate and estimate repairs.

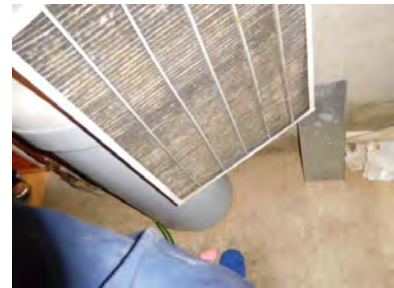
- 13. Basement Utility Room Heating System Blower Fan/Filter:** Repair or replacement is recommended. The furnace filter is very dirty - Suggest replacing for proper efficiency of the HVAC system. This is evidence of a lack of proper maintenance. Cleaning of the HVAC system & Service by a qualified HVAC specialists is recommended for proper operation.

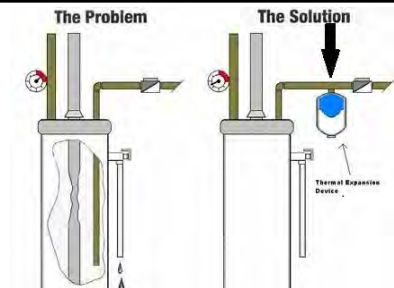
- 14. Basement Utility Room / Closet Water Heater Expansion Tank Present: No - -** Today's standards call for an expansion tank, typically above the water heater to be installed especially when there is a pressure regulator installed on the incoming service water line; this allows the hot water to expand as the heat builds up and not put additional pressure on the tank's temperature relief valve and plumbing system which can cause water leakage. The water heater has been recently installed. Recommend proper installation of a thermal expansion tank.

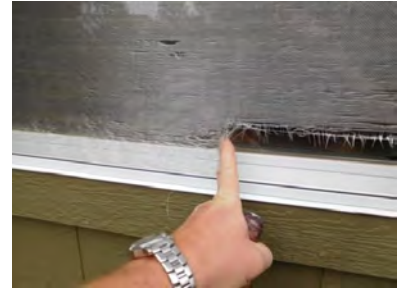
- Window Screens:** Repair or replacement is recommended. The window screen is in need of repair or replacement; Recommend the proper repairs be made as needed., The majority of the windows have this condition.

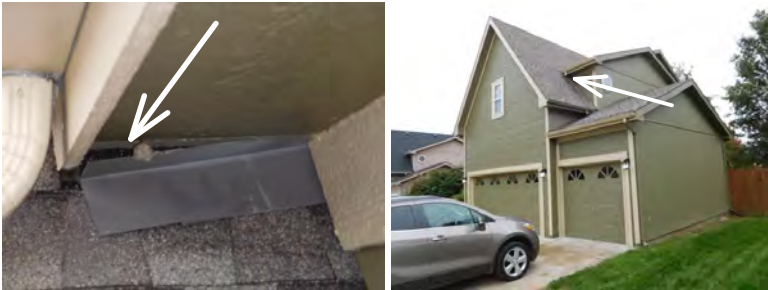
- Flashing:** Metal flashing - - Hole noted underneath soffit - Suggest sealing this area usually with metal flashing to help prevent wind driven moisture and or unwanted pests from entering structure.

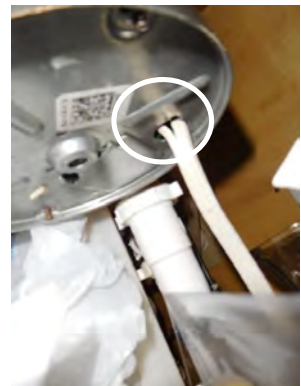
- Main Floor Kitchen Cooking Appliances:** Repair or replacement is recommended. The stove is not secured to the floor and can easily tip over when weight is applied to the door when open. Recommend installing the safety device that comes with all stoves when sold and locks the rear leg of the stove to the floor for added safety.
- Main Floor Kitchen Disposal:** Repair or replacement is recommended. The electrical stress clamp is missing - Suggest installing a stress clamp at the garbage disposal electrical wiring entry to properly secure the electrical wiring to the appliance to prevent a possible loose electrical connection for added safety.

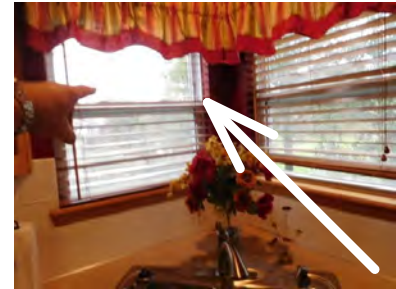
7. **Windows:** Repair or replacement is recommended. One or more insulated glass windows have lost their vacuum seal. As a result of losing this seal, condensation between the two panes can create a clouded or streaked appearance. The window still performs the task of keeping the weather out. Recommend repair or replace as needed.

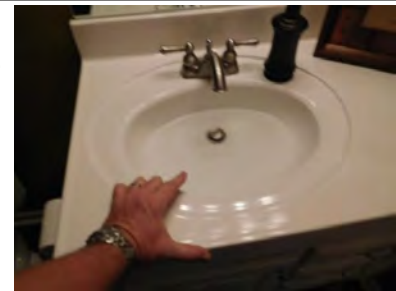
8. **Basement Bathroom Sink/Basin:** Repair or replacement is recommended. Slow drain is noted, this may be due to hair clog in the p-trap; Recommend the proper repairs be made for proper drainage.

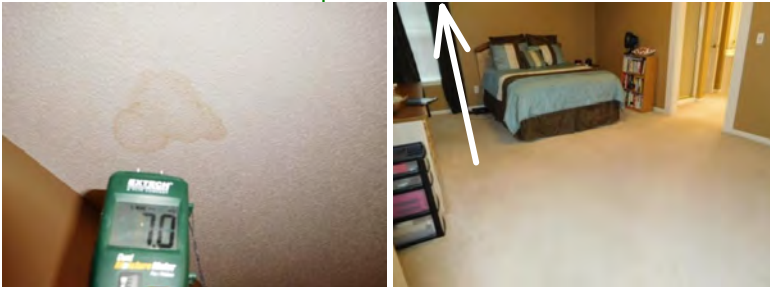
9. **Master Bedroom Ceiling:** Repair or replacement is recommended. Water stains present which tested negative for moisture content at the time of inspection. The stains are located below a roof plumbing vent. The stains appear old and to have been repaired when the recent roof material was installed.

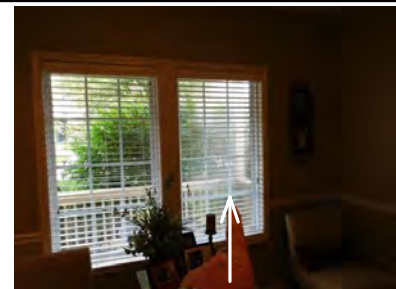
10. **Dining Room Living Space Windows:** Repair or replacement is recommended. One of the insulated glass windows have lost their vacuum seal. As a result of losing this seal, condensation between the two panes can create a clouded or streaked appearance. The window still performs the task of keeping the weather out. Recommend repair or replace as needed.

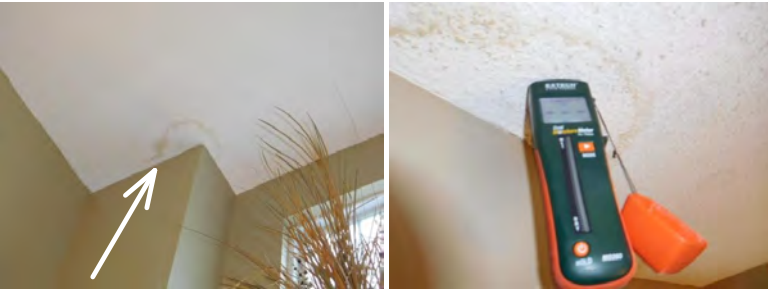
11. **Hallway / Entryway Living Space Ceiling:** Repair or replacement is recommended. Water stains present which tested negative for moisture content at the time of inspection. The stains appear old and to have been repaired when the recent roof material was installed.

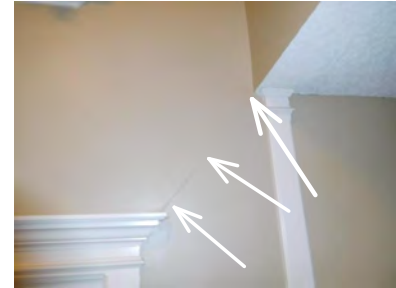
- 12. Hallway / Entryway Living Space Walls:** Repair or replacement is recommended. There is some minor cracking noted that does not appear to be a serious structural concern at this time. Be sure to take note of any future movement. Most minor cracking is due to shrinkage of the construction materials.

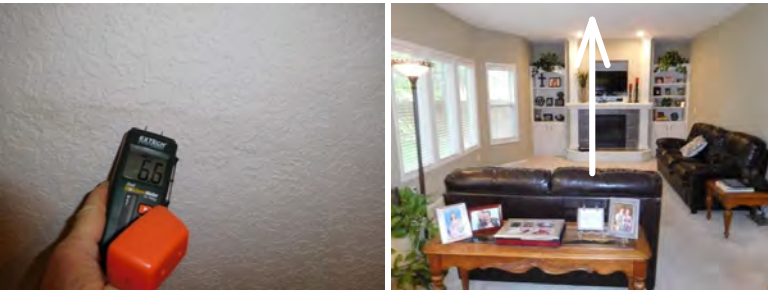
- 13. Living Room Living Space Ceiling:** Repair or replacement is recommended. Water stains present which tested negative for moisture content at the time of inspection - Suggest monitoring for moisture activity and repair as needed.

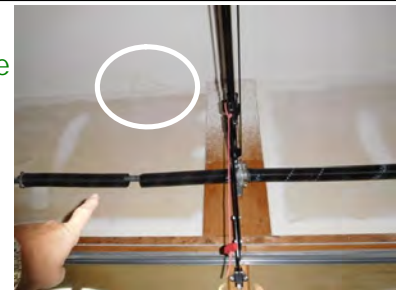
- 14. The garage is located at the front of the structure. Garage Ceiling:** Repair or replacement is recommended. Water stains present which tested negative for moisture content at the time of inspection - Suggest monitoring for moisture activity and repair as needed.

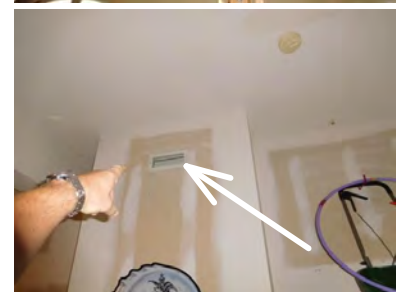
- 15. The garage is located at the front of the structure. Garage Heating:** Repair or replacement is recommended. Garage supply air ventilation is noted. Today's standards require a fire damper at the ductwork when installed in the garage area. It is recommended a fire damper be installed inside the ductwork at the vent for added safety.

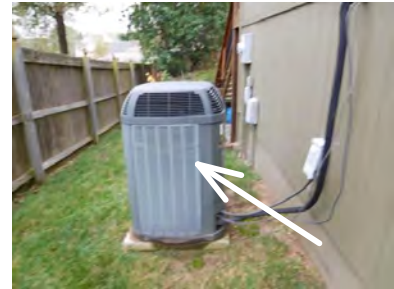
- 16. Outside Unit AC System Visible Coil:** Repair or replacement is recommended. The A/C coil is dirty; Recommend cleaning the exterior A/C coil for improved efficiency of the A/C unit.

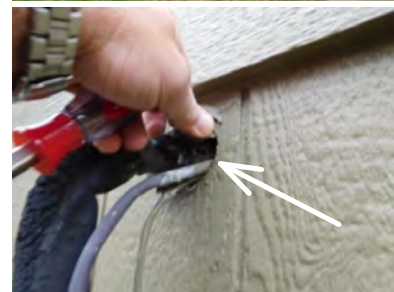
- 17. Outside Unit AC System Refrigerant Lines:** Repair or replacement is recommended. The point of entry where A/C refrigerant lines pass through the structure is not sealed - Suggest sealing this area to prevent moisture entry and improved efficiency of the home.

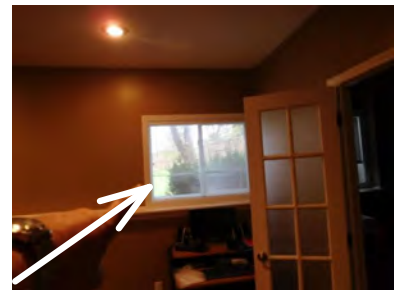
- 19. Entire Basement Area Basement Windows:** Repair or replacement is recommended. One or more insulated glass windows have lost their vacuum seal. As a result of losing this seal, condensation between the two panes can create a clouded or streaked appearance. The window still performs the task of keeping the weather out. Recommend repair or replace as needed.

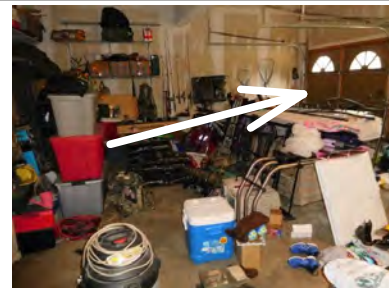
- 1. The garage is located at the front of the structure. Garage Door Operation:** This item was not inspected at the time of inspection. The 3rd car garage door is blocked by storage; unable to operate or visually inspect. Recommend proper operation be verified prior to purchase.

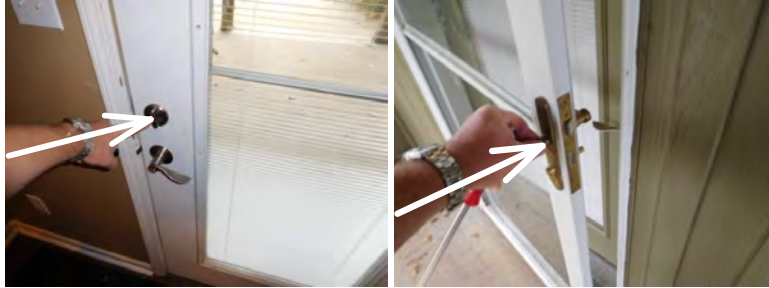
The storm door lockset(s) not properly latching / functioning; Recommend properly repair or replace.

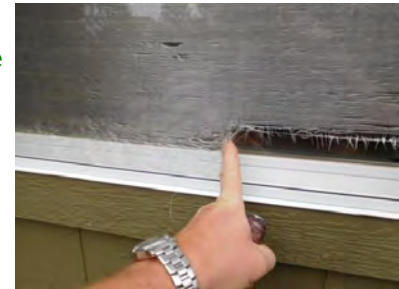
Window Screens: Repair or replacement is recommended. The window screen is in need of repair or replacement; Recommend the proper repairs be made as needed., The majority of the windows have this condition.

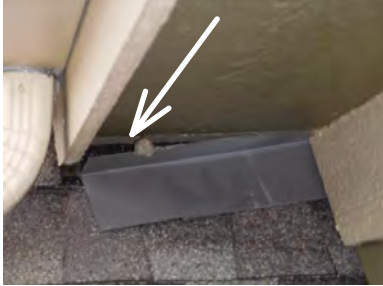
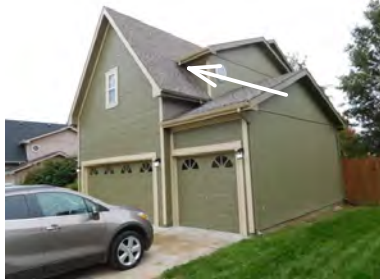
9. Attention Needed **Flashing:** Metal flashing - - Hole noted underneath soffit - Suggest sealing this area usually with metal flashing to help prevent wind driven moisture and or unwanted pests from entering structure.

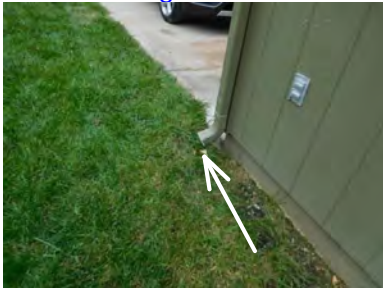
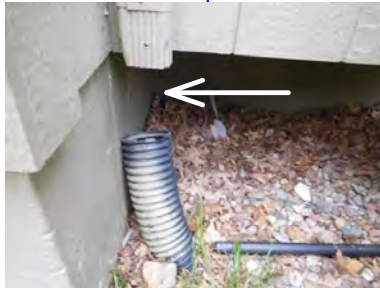
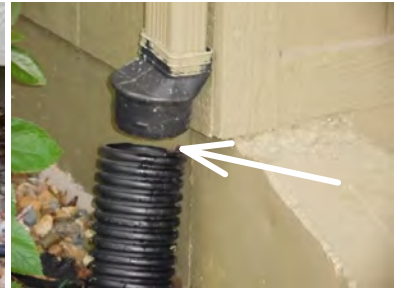
Leader/Extension: Repair or replacement is recommended. The downspout extensions are not properly installed, missing, disconnected or tilting towards the structure. This is allowing water to accumulate around the foundation which is known to cause foundation problems when left unattended also moist areas around the home are attractive to termites. Suggest extending leaders at least 6 feet beyond the foundation perimeter at a minimum to protect and prevent water damage to the foundation at all downspout locations.

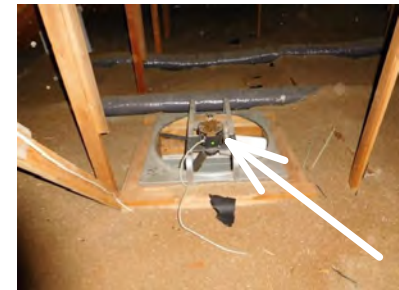
11. Action Needed **House Fan:** Repair or replacement is recommended. The fan does not pull much air. Inadequate ventilation of the attic is noted along with the fan belt needs adjustment to properly vent the home. A qualified contractor is recommended to further evaluate and estimate repairs.

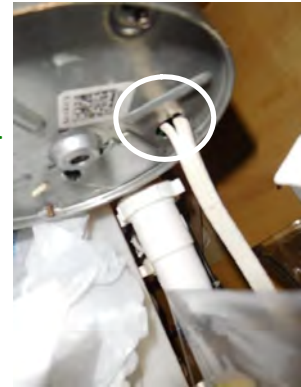
3. Attention Needed **Disposal:** Repair or replacement is recommended. The electrical stress clamp is missing - Suggest installing a stress clamp at the garbage disposal electrical wiring entry to properly secure the electrical wiring to the appliance to prevent a possible loose electrical connection for added safety.

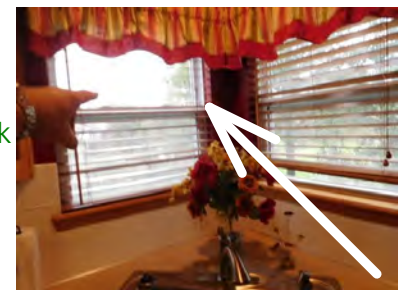
13. Attention Needed **Windows:** Repair or replacement is recommended. One or more insulated glass windows have lost their vacuum seal. As a result of losing this seal, condensation between the two panes can create a clouded or streaked appearance. The window still performs the task of keeping the weather out. Recommend repair or replace as needed.

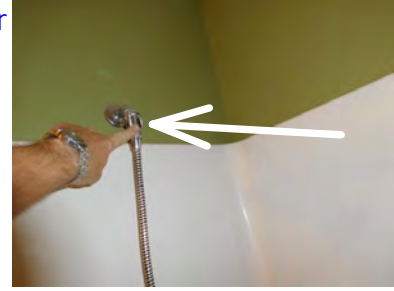
25. Action Needed **Tub/Surround:** Repair or replacement is recommended. The shower head bracket is broken and the shower head has to lay on the bottom of the tub. Recommend proper replacement.

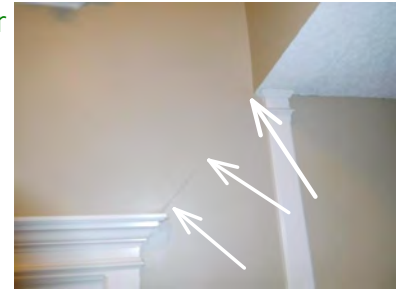
16. Attention Needed **Walls:** Repair or replacement is recommended. There is some minor cracking noted that does not appear to be a serious structural concern at this time. Be sure to take note of any future movement. Most minor cracking is due to shrinkage of the construction materials.

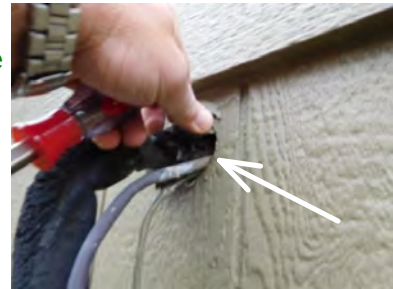
10. Attention Needed **Refrigerant Lines:** Repair or replacement is recommended. The point of entry where A/C refrigerant lines pass through the structure is not sealed - Suggest sealing this area to prevent moisture entry and improved efficiency of the home.

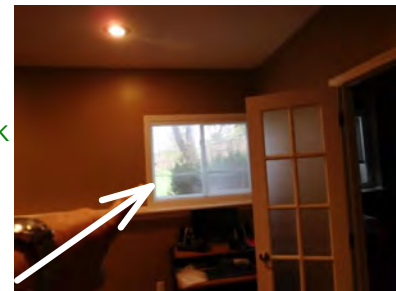
4. Inspected **Floor:** Functional / In Serviceable Condition.
5. Inspected **Doors:** Functional / In Serviceable Condition.
6. Attention Needed **Windows:** Repair or replacement is recommended. One or more insulated glass windows have lost their vacuum seal. As a result of losing this seal, condensation between the two panes can create a clouded or streaked appearance. The window still performs the task of keeping the weather out. Recommend repair or replace as needed.
