HOME INSPECTION REPORT

Premier Inspection Services, Inc.
118 North Conistor Lane Ste B #180
Liberty, MO 64068
Office Phone: 816.407.1617
www.kchomeinspector.com

Action Needed Summary

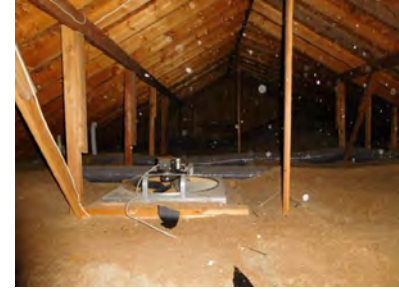
6. **ALL Attic Locations Attic Ventilation:** Repair or replacement is recommended. There is evidence of moisture / condensation building up in the attic area due to the moisture stains on the insulation. The moisture is building up and collecting on the roof sheathing and then dripping on to the insulation causing these stains. This condition is usually caused by improper ventilation of the attic and or heat escaping the living areas into the attic causing hot air to condensate. A qualified contractor is recommended to further evaluate and estimate repairs. Typically the improvements needed are 2 fold. 1.) Is to seal air penetration areas that lead from the living space to the attic and 2.) Improvements be made to the attic ventilation such as additional roof and or soffit vents. Current industry standards recommend, as a minimum, one square foot of free vent area for each 150 square feet of attic floor if no vapor barrier is installed. With a vapor barrier installed, one square foot of free vent area per 300 square feet of attic space is needed.

7. Action Needed **Ventilation:** Repair or replacement is recommended. There is evidence of moisture / condensation building up in the attic area due to the moisture stains on the insulation. The moisture is building up and collecting on the roof sheathing and then dripping on to the insulation causing these stains. This condition is usually caused by improper ventilation of the attic and or heat escaping the living areas into the attic causing hot air to condensate. A qualified contractor is recommended to further evaluate and estimate repairs. Typically the improvements needed are 2 fold. 1.) Is to seal air penetration areas that lead from the living space to the attic and 2.) Improvements be made to the attic ventilation such as additional roof and or soffit vents. Current industry standards recommend, as a minimum, one square foot of free vent area for each 150 square feet of attic floor if no vapor barrier is installed. With a vapor barrier installed, one square foot of free vent area per 300 square feet of attic space is needed.

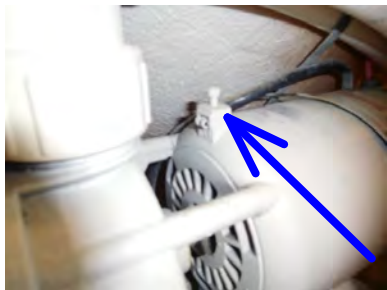
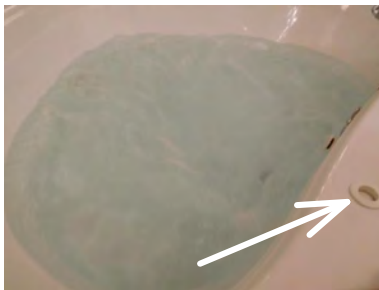
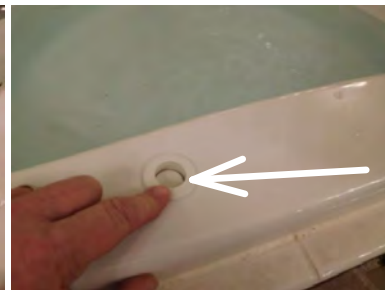
8. **Master Bedroom Bathroom Spa Tub/Surround:** Repair or replacement is recommended. The spa pump motor bond wire is missing / not attached to the motor housing ground / bond connection. Recommend properly bonding the spa pump motor. Typically the bond /ground wire is connected from the motor housing set screw and metal faucet / plumbing to the electrical panel. The control knob or push button is in need of repair or replacement due to it is stuck in the down position; Recommend the proper repairs be made.

11. Inspected **Faucets/Traps:** Functional / In Serviceable Condition.
12. Inspected **Shower/Surround:** Functional / In Serviceable Condition.
13. Action Needed **Spa Tub/Surround:** Repair or replacement is recommended. The spa pump motor bond wire is missing / not attached to the motor housing ground / bond connection. Recommend properly bonding the spa pump motor. Typically the bond /ground wire is connected from the motor housing set screw and metal faucet / plumbing to the electrical panel. The control knob or push button is in need of repair or replacement due to it is stuck in the down position; Recommend the proper repairs be made.

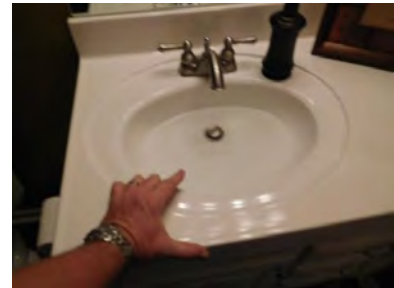
8. **Basement Bathroom Sink/Basin:** Repair or replacement is recommended. Slow drain is noted, this may be due to hair clog in the p-trap; Recommend the proper repairs be made for proper drainage.

46. Attention Needed **Sink/Basin:** Repair or replacement is recommended. Slow drain is noted, this may be due to hair clog in the p-trap; Recommend the proper repairs be made for proper drainage.

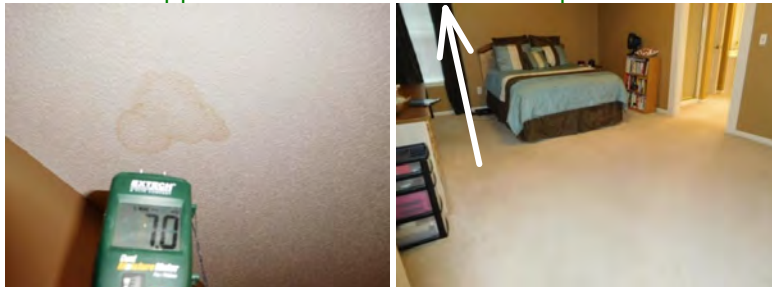
9. **Master Bedroom Ceiling:** Repair or replacement is recommended. Water stains present which tested negative for moisture content at the time of inspection. The stains are located below a roof plumbing vent. The stains appear old and to have been repaired when the recent roof material was installed.

- 1. Attention Needed **Ceiling:** Repair or replacement is recommended. Water stains present which tested negative for moisture content at the time of inspection. The stains are located below a roof plumbing vent. The stains appear old and to have been repaired when the recent roof material was installed.

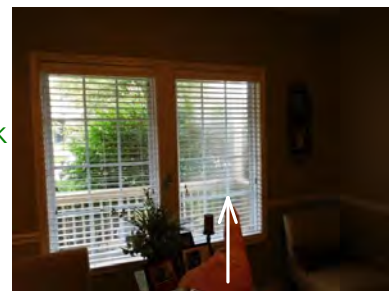
10. **Dining Room Living Space Windows:** Repair or replacement is recommended. One of the insulated glass windows have lost their vacuum seal. As a result of losing this seal, condensation between the two panes can create a clouded or streaked appearance. The window still performs the task of keeping the weather out. Recommend repair or replace as needed.

8. Inspected **Ceiling:** Functional / In Serviceable Condition.
9. Inspected **Walls:** Functional / In Serviceable Condition.
10. Inspected **Floor:** Functional / In Serviceable Condition.
11. Attention Needed **Windows:** Repair or replacement is recommended. One of the insulated glass windows have lost their vacuum seal. As a result of losing this seal, condensation between the two panes can create a clouded or streaked appearance. The window still performs the task of keeping the weather out. Recommend repair or replace as needed.

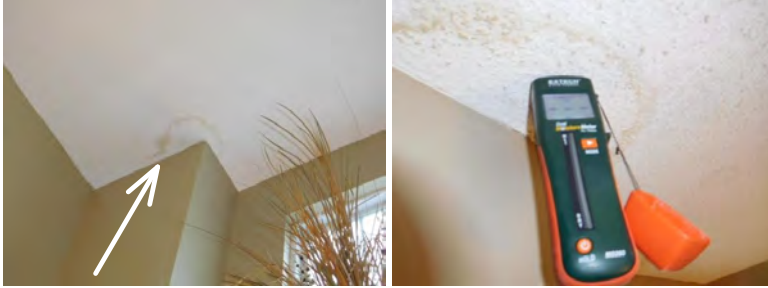
11. **Hallway / Entryway Living Space Ceiling:** Repair or replacement is recommended. Water stains present which tested negative for moisture content at the time of inspection. The stains appear old and to have been repaired when the recent roof material was installed.

15. Attention Needed **Ceiling:** Repair or replacement is recommended. Water stains present which tested negative for moisture content at the time of inspection. The stains appear old and to have been repaired when the recent roof material was installed.

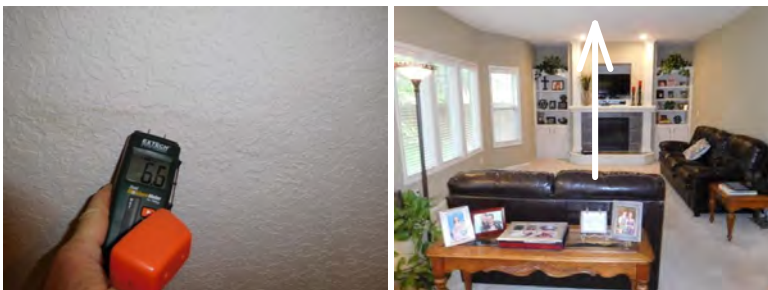
- 13. Living Room Living Space Ceiling:** Repair or replacement is recommended. Water stains present which tested negative for moisture content at the time of inspection - Suggest monitoring for moisture activity and repair as needed.

22. Attention Needed **Ceiling:** Repair or replacement is recommended. Water stains present which tested negative for moisture content at the time of inspection - Suggest monitoring for moisture activity and repair as needed.

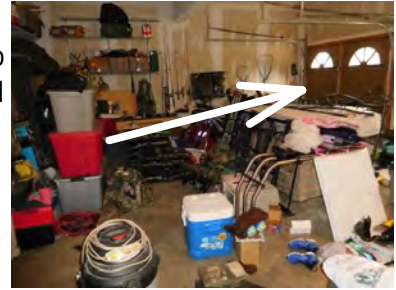
3. Not Inspected

- 1. The garage is located at the front of the structure. Garage Door Operation:** This item was not inspected at the time of inspection. The 3rd car garage door is blocked by storage; unable to operate or visually inspect. Recommend proper operation be verified prior to purchase.

Door Operation: This item was not inspected at the time of inspection. The 3rd car garage door is blocked by storage; unable to operate or visually inspect. Recommend proper operation be verified prior to purchase.

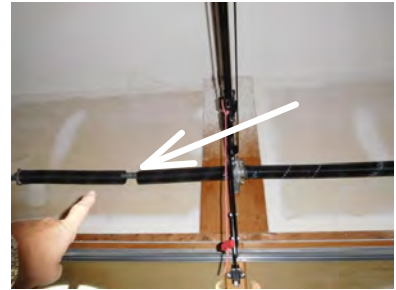
4. Action Needed

- 12. The garage is located at the front of the structure. Garage Door Opener:** Repair or replacement is recommended. The garage door opener was inoperative at the time of inspection. The garage door spring(s) is broken. Recommend proper replacement. A qualified contractor is recommended to evaluate and estimate repairs.

Door Opener: Repair or replacement is recommended. The garage door opener was inoperative at the time of inspection. The garage door spring(s) is broken. Recommend proper replacement. A qualified contractor is recommended to evaluate and estimate repairs.

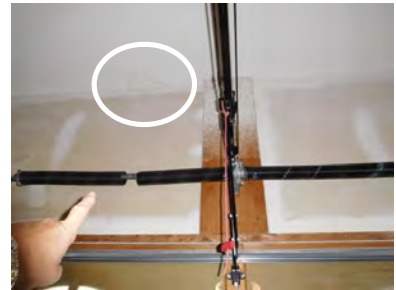
6. Attention Needed

- 14. The garage is located at the front of the structure. Garage Ceiling:** Repair or replacement is recommended. Water stains present which tested negative for moisture content at the time of inspection - Suggest monitoring for moisture activity and repair as needed.

Ceiling: Repair or replacement is recommended. Water stains present which tested negative for moisture content at the time of inspection - Suggest monitoring for moisture activity and repair as needed.

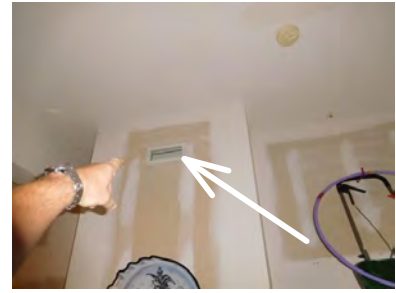
- 15. The garage is located at the front of the structure. Garage Heating:** Repair or replacement is recommended. Garage supply air ventilation is noted. Today's standards require a fire damper at the ductwork when installed in the garage area. It is recommended a fire damper be installed inside the ductwork at the vent for added safety.

- 10. Attention Needed Heating:** Repair or replacement is recommended. Garage supply air ventilation is noted. Today's standards require a fire damper at the ductwork when installed in the garage area. It is recommended a fire damper be installed inside the ductwork at the vent for added safety.

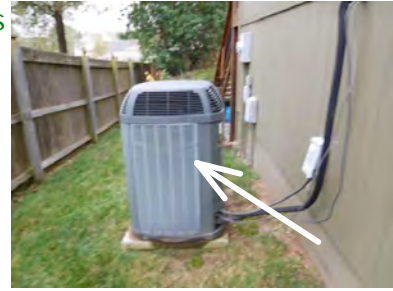
- 16. Outside Unit AC System Visible Coil:** Repair or replacement is recommended. The A/C coil is dirty; Recommend cleaning the exterior A/C coil for improved efficiency of the A/C unit.

2. Inspected **A/C System Operation:** Functional / In Serviceable Condition.
3. Inspected **Condensate Removal:** Functional / In Serviceable Condition.
4. Inspected **Exterior Unit:** Pad mounted
5. **Manufacturer:** Trane
6. **Area Served:** Whole building / **Approximate Age:** 13-15 Yrs
7. **Fuel Type:** 220-240 VAC / **Temperature Differential:** 20
8. **Type:** Central A/C & Heat Pump. / **Capacity:** 4 Ton
9. Attention Needed **Visible Coil:** Repair or replacement is recommended. The A/C coil is dirty; Recommend cleaning the exterior A/C coil for improved efficiency of the A/C unit.

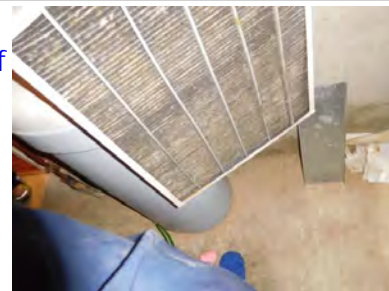
- 13. Basement Utility Room Heating System Blower Fan/Filter:** Repair or replacement is recommended. The furnace filter is very dirty - Suggest replacing for proper efficiency of the HVAC system. This is evidence of a lack of proper maintenance. Cleaning of the HVAC system & Service by a qualified HVAC specialists is recommended for proper operation.

8. Action Needed **Blower Fan/Filter:** Repair or replacement is recommended. The furnace filter is very dirty - Suggest replacing for proper efficiency of the HVAC system. This is evidence of a lack of proper maintenance. Cleaning of the HVAC system & Service by a qualified HVAC specialists is recommended for proper operation.

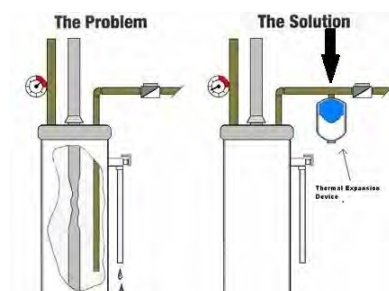
- 14. Basement Utility Room / Closet Water Heater Expansion Tank Present: No - -** Today's standards call for an expansion tank, typically above the water heater to be installed especially when there is a pressure regulator installed on the incoming service water line; this allows the hot water to expand as the heat builds up and not put additional pressure on the tank's temperature relief valve and plumbing system which can cause water leakage. The water heater has been recently installed. Recommend proper installation of a thermal expansion tank.

9. Inspected **Water Heater Operation:** Functional at time of inspection.
 10. **Expansion Tank Present: No** - - Today's standards call for an expansion tank, typically above the water heater to be installed especially when there is a pressure regulator installed on the incoming service water line; this allows the hot water to expand as the heat builds up and not put additional pressure on the tank's temperature relief valve and plumbing system which can cause water leakage. The water heater has been recently installed. Recommend proper installation of a thermal expansion tank.

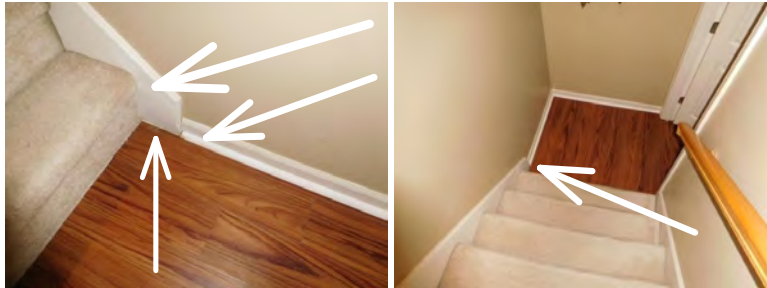
- 18. Entire Basement Area Basement Walls:** Functional / In Serviceable Condition. Water stains present which tested negative for moisture content at the time of inspection. The water stains appear to have come from the A/C condensation drain line at the back side of this wall and appear to be old stains as there is evidence that this condition has been repaired. - Suggest monitoring for moisture activity and repair as needed.

1. Inspected **Unable to Inspect:** 90+% - - Of the interior foundation walls due to wall and ceiling finishing.
2. Inspected **Ceiling:** Functional / In Serviceable Condition.
3. Attention Needed **Walls:** Functional / In Serviceable Condition. Water stains present which tested negative for moisture content at the time of inspection. The water stains appear to have come from the A/C condensation drain line at the back side of this wall and appear to be old stains as there is evidence that this condition has been repaired. - Suggest monitoring for moisture activity and repair as needed.
